TROUBLESHOOTING GUIDE FOR LK BREAKER
TRIP-FREE AND MAG LATCH SHOCK-OUT

IB 8603

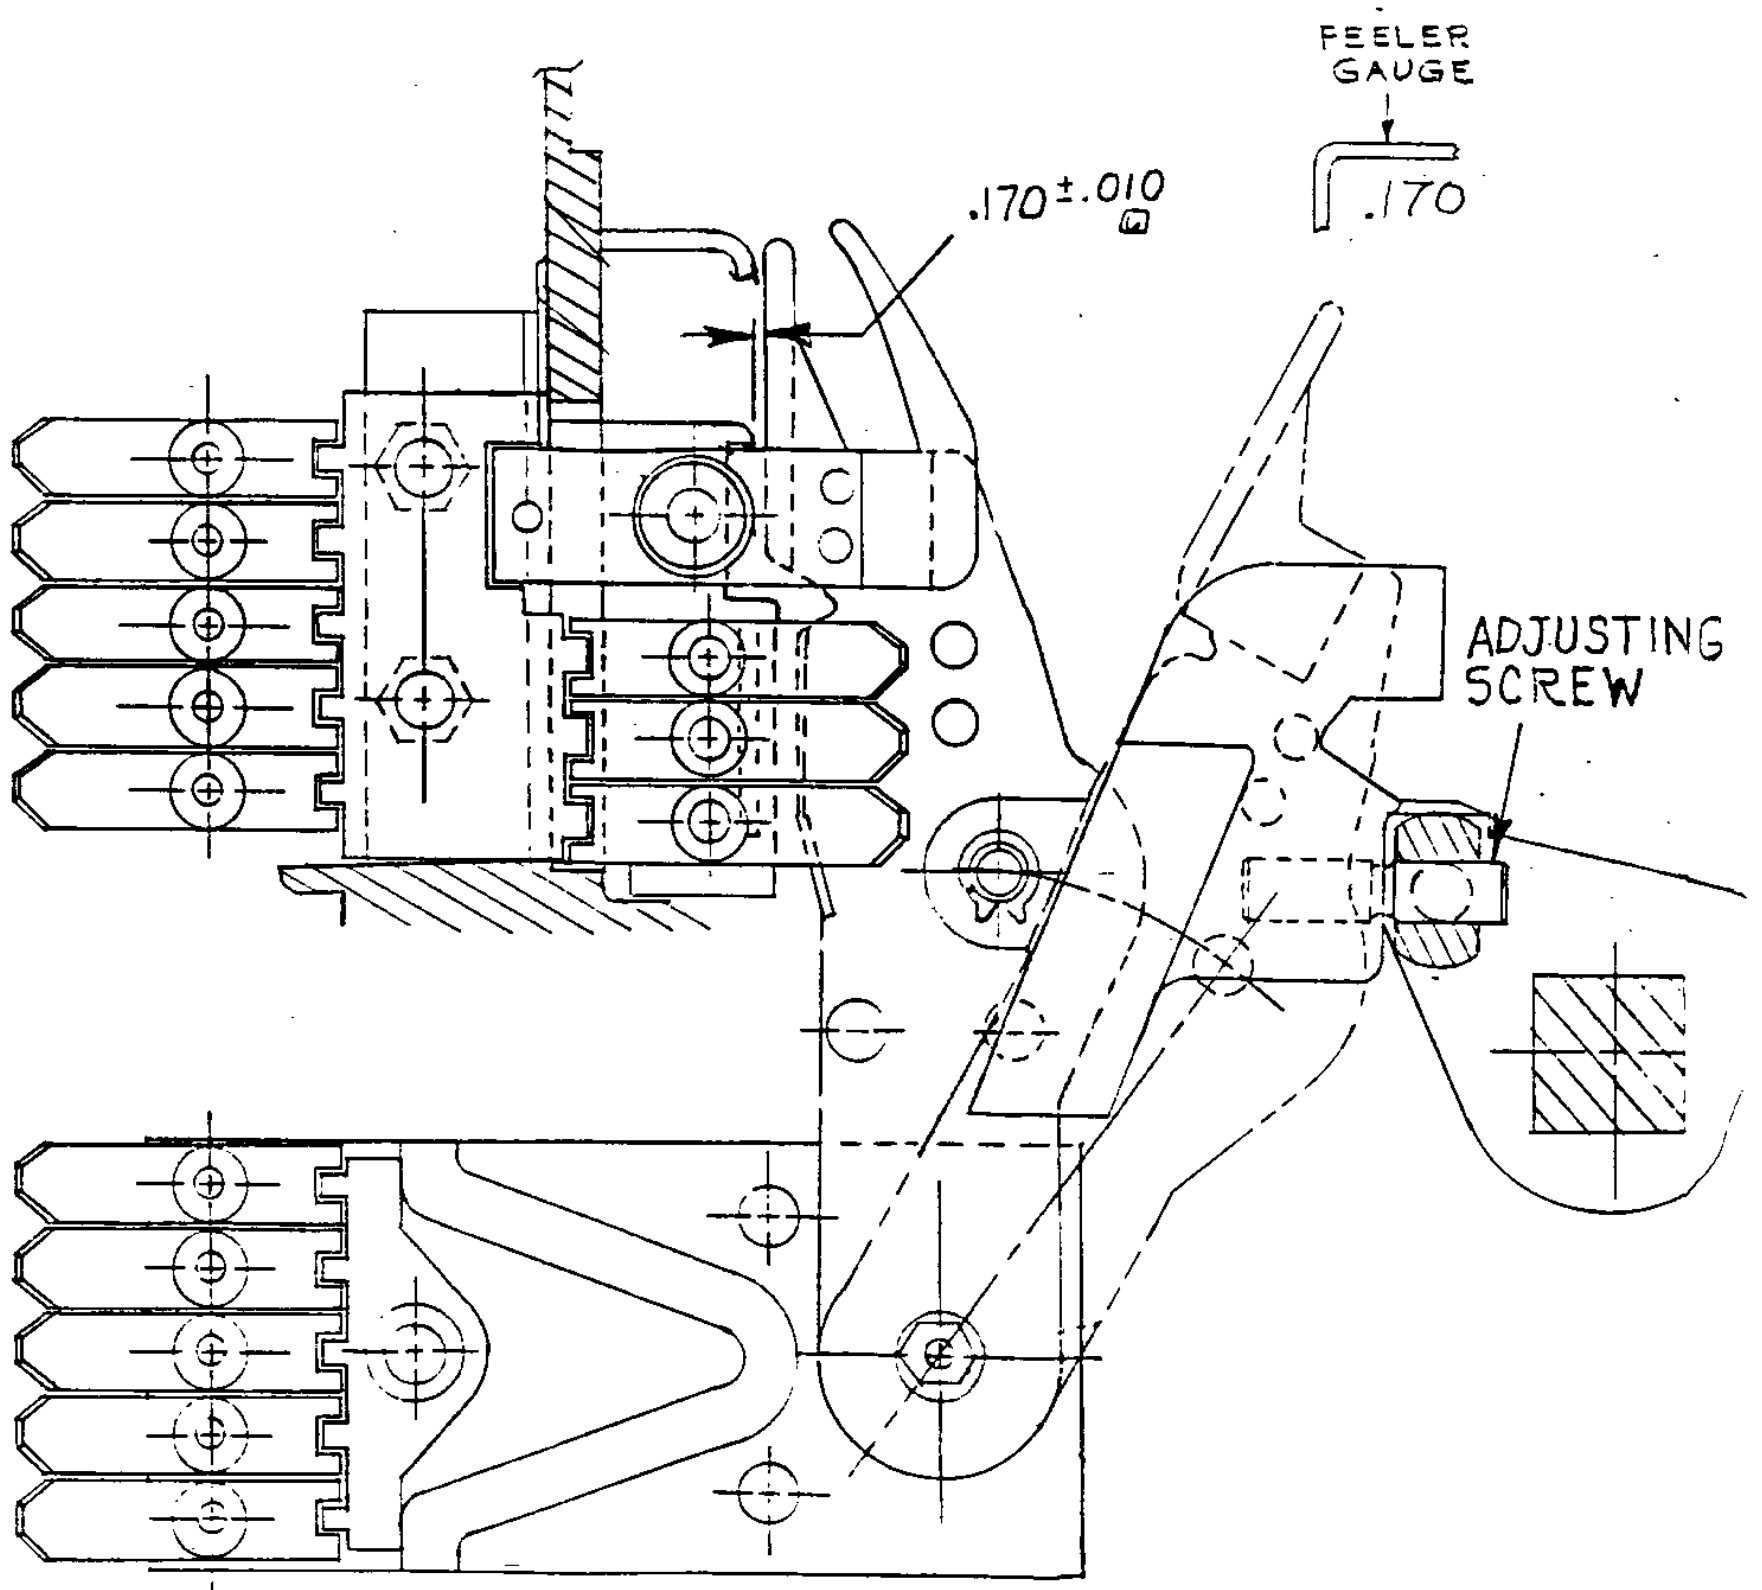
ILLUSTRATION 1

3. Improper contact penetration gap - When the contact gap (the distance from the bridge blade arcing contact to the forward face of the upper terminal when the breaker is closed) (see Illustration No. 1) is less than 0.100 inches, the circuit breaker toggle assembly (which is attached to the jackshaft) is positioned improperly. That, in turn prevents the track assembly from seating against the trip latch properly. This is diagnosed by lifting the trip latch with the contacts open and the springs discharged (assuming that there is no escutcheon interference). The trip latch will feel like it's contacting the track assembly and pushing it rearward as it rolls on the roller of that assembly. With the breaker closed, this problem manifests itself with exceedingly high trip latch lifting forces. The standard force for lifting the trip latch should fall between 1-1/2 and 4 pounds. Higher forces, such as 8 pounds or more are a sure sign of insufficient contact gap. Insufficient contact gap is also a leading cause of trip lever breaking in breakers since it forces the trip latch hard against the front escutcheon during a trip operation.

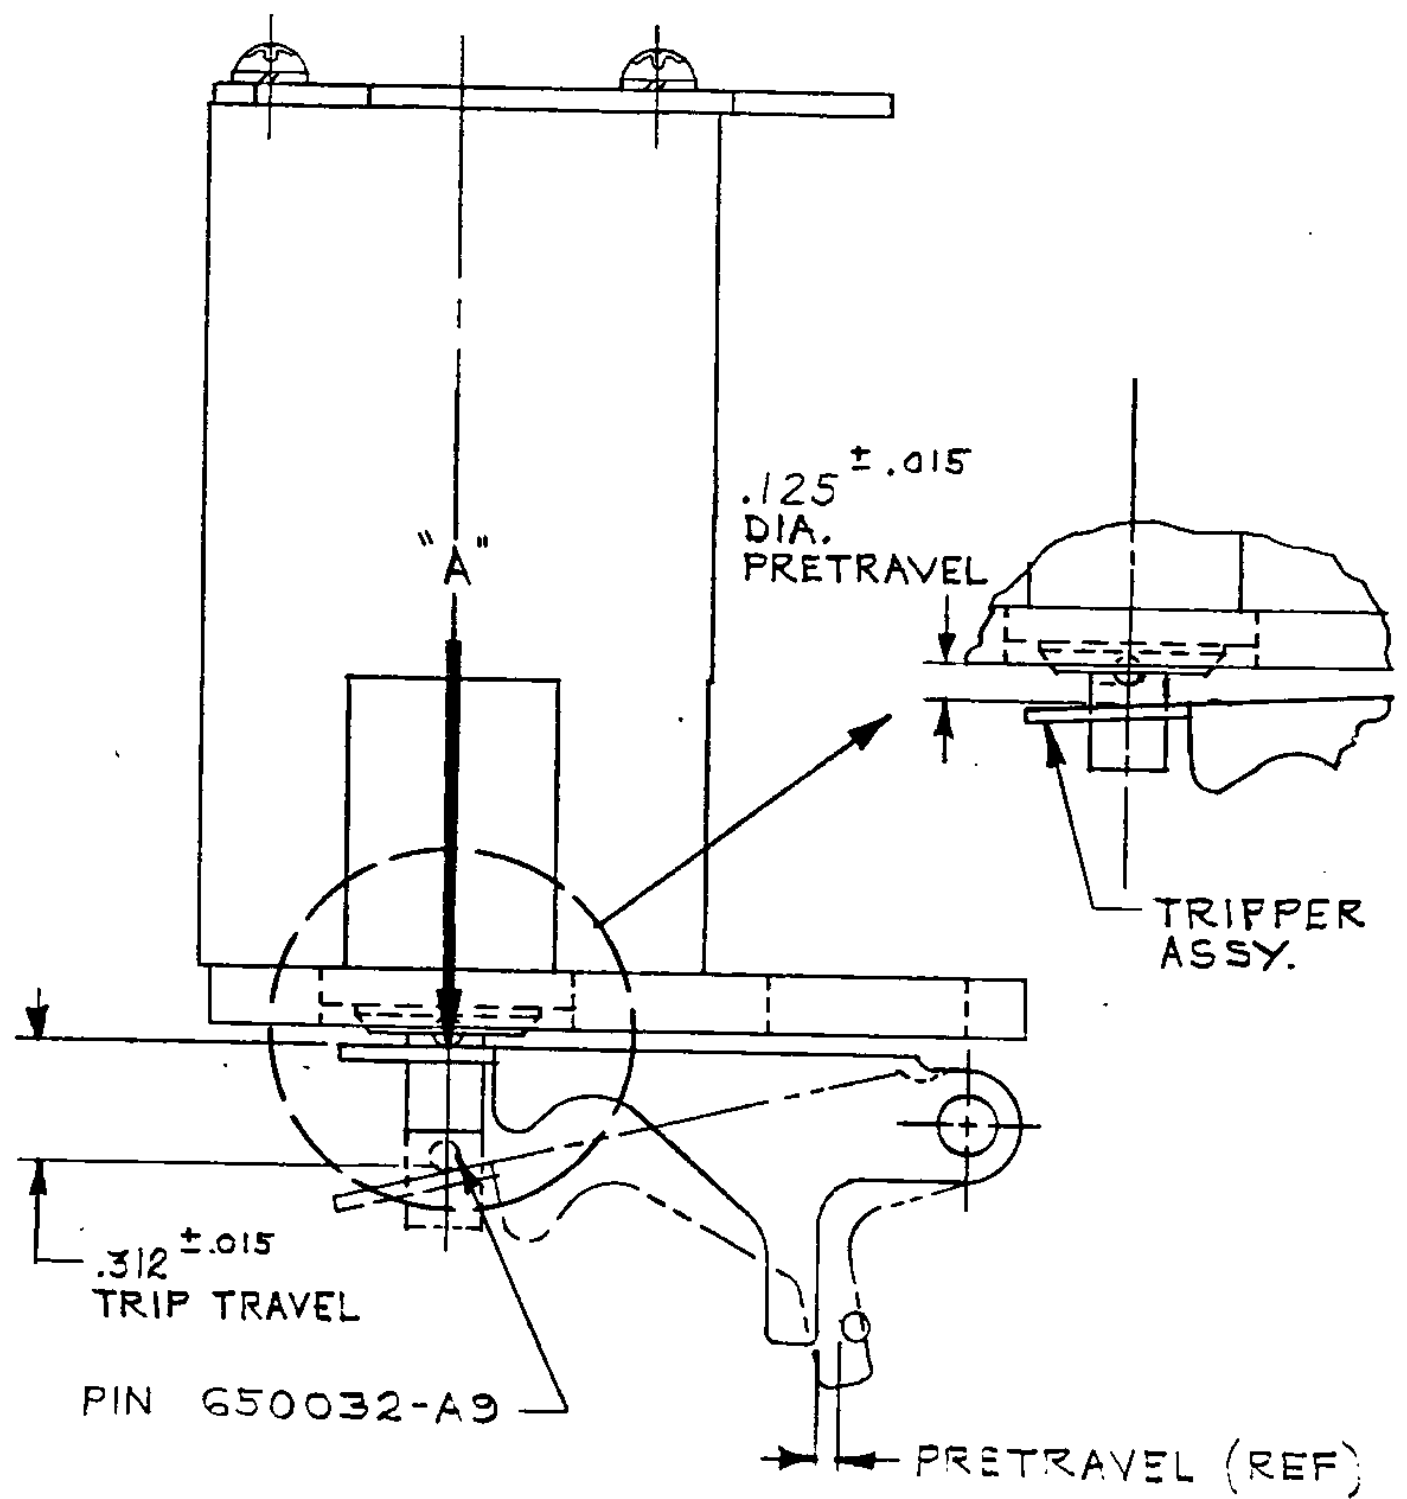
ILLUSTRATION 2

Pretravel was alluded to above. Mag latch pretravel is shown on illustration 2 attached. If there is insufficient pretravel, the mag latch will not trip the breaker. Pretravel is measured when the breaker is closed. On small frame breakers, carefully pull down the mag latch tripper and measure the gap between the tripper and the platform the mag latch sits on. It should be 0.125 ± 0.015 . On large frame breakers, this same gap will exist between the tripper and the platform, but will also be between the horizontal tripper assembly and the cross pin of the mag latch plunger, when the contacts are closed.
