Non Ceramic Insulator Workshop

Presented by R. Allen Bernstorf
The Dalles, Oregon
May 6, 1993

**NON CERAMIC INSULATOR WORKSHOP
PRESENTED BY R. ALLEN BERNSTORF
THE DALLES, OREGON
MAY 6, 1993**

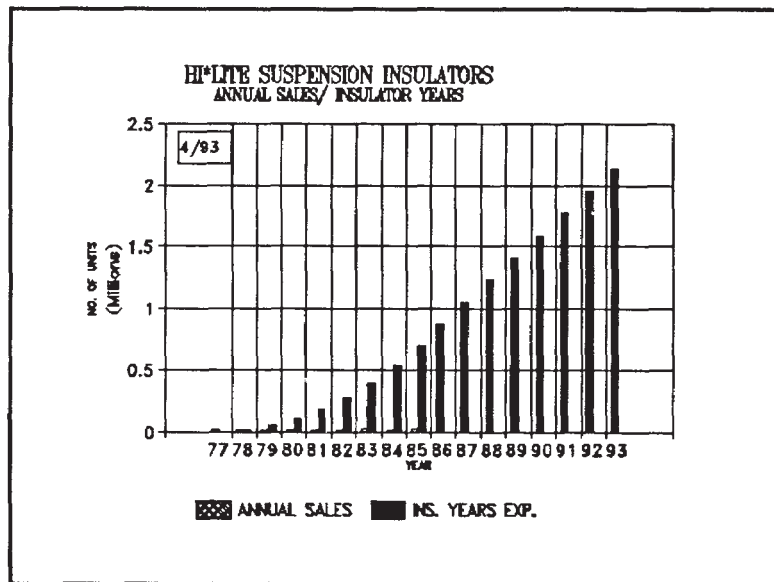
FIGURE 4

Although these problems sound serious, the general experience with the Hi*Lite design was favorable. By the time the second generation Hi*Lite design was introduced in 1986, over 600,000 insulator years of experience had been accrued, and today, the experience for the first generation Hi*Lite design is over 2 million insulator years (see figure 4).

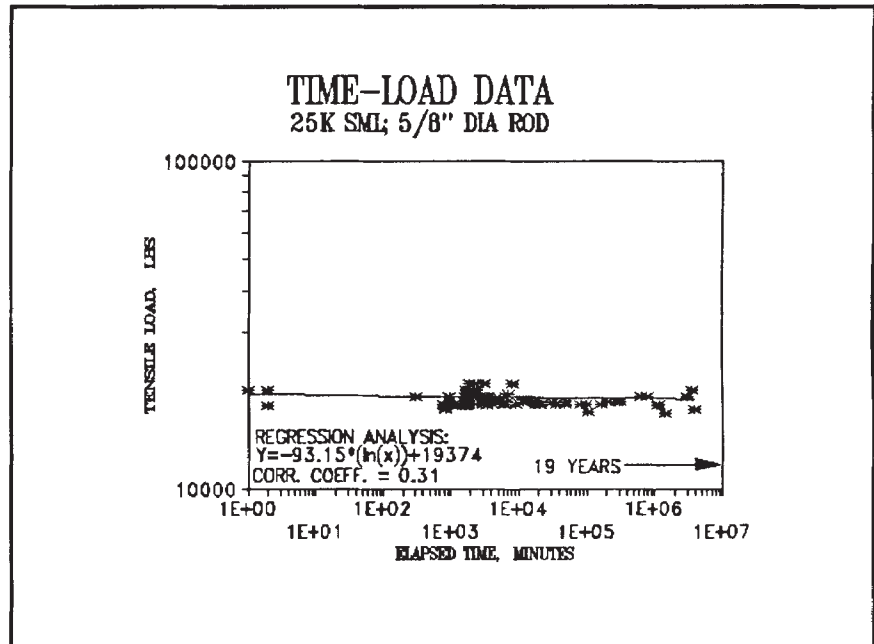
FIGURE 16

Time-load deals with the ability of an insulator to support a given load for a long period of time. It is often confused with the ultimate strength of the insulator at any given point in time. The data plotted in figure 16 represents constant loads applied for some time period; in this case, until failure of the specimen occurs.

The curve (figure 16) represents data collected on insulators with a rod size equivalent to that used in Ohio Brass's current 25,000 lb SML insulators. The word "equivalent" should be emphasized. When these insulators were manufactured with a 5/8" diameter rod, the guaranteed minimum ultimate strength was 20,000 lbs. Each of the asterisks represent a failure point.

performed on this data. That equation is shown on the plot. The correlation for time-load data is typically not very good, but it gives a general idea of the slope of the curve.

Please note that the regression line does not pass through the current SML for this rod size, nor does it threaten the RTL at any time in the foreseeable future. More than 95% of the insulators

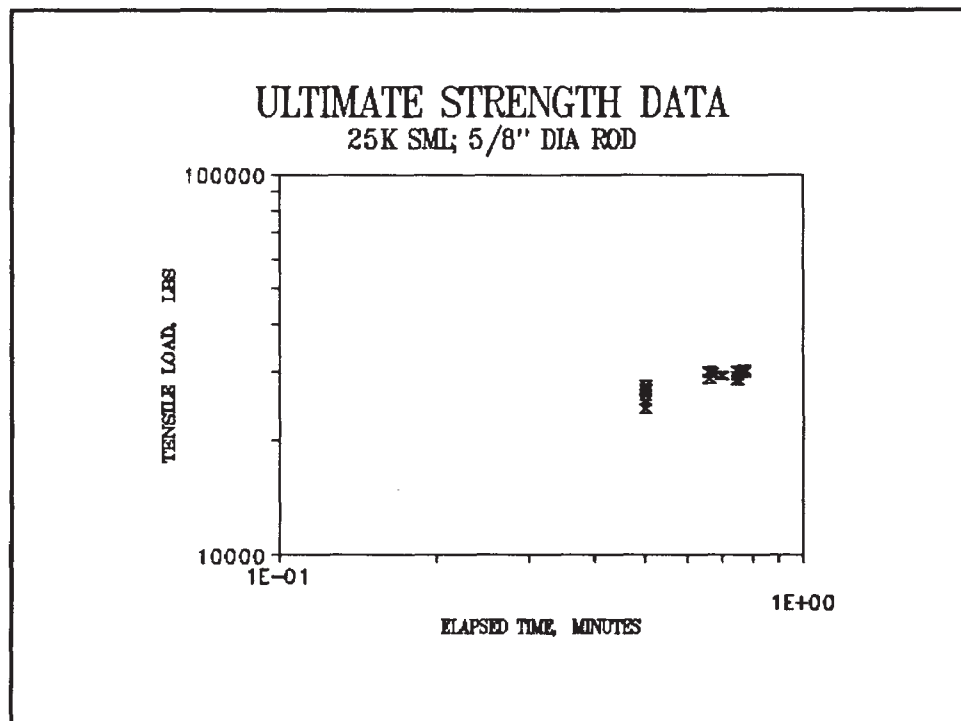
FIGURE 17

When Ohio Brass began performing time load testing, an ultimate strength test was performed on every third insulator manufactured as a control group. Please bear in mind that these insulators were rated for an SML of 20,000 lbs, with an average ultimate strength of 25,000 lbs. The load was applied at a constant rate of rise until the insulator failed. The ultimate strength failures consisted of rod failures, hardware failures, and crimp slips (see figure 17).

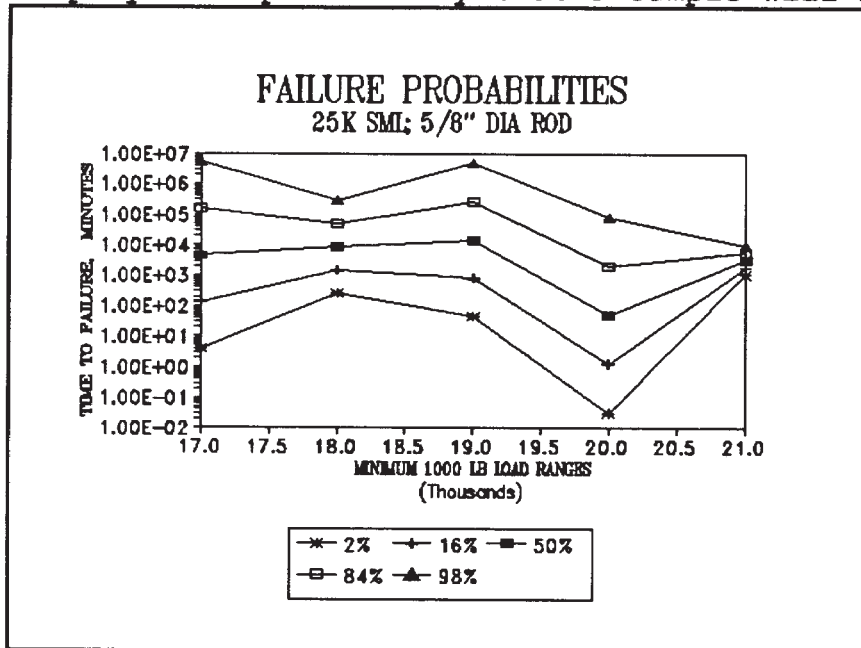
FIGURE 21

Figure 21 displays the probability that a sample will have failed within a given time at a number of different loads. The lower the constant load applied, the lower the probability of failure within any specified time.
